THE WHITE CHURCH IS BACK

Located on the north-east edge of Trafalgar Square, St Martin-in-the-Fields is justifiably regarded as one of the country's finest historic churches. The masterpiece of distinguished 18th-century architect James Gibbs, it was consecrated in 1726 and has become an architectural and social landmark in the capital and a template for church architecture around the world. But 275 years of exposure to the environment and humanity had taken a heavy toll – by 2001 it was clear that work was needed to preserve its architectural splendour and allow the community work for which it is renowned to continue to thrive. Eric Parry Architects' master plan promised to do just that. It was a bold design that would dramatically increase the size of the church's undercroft to provide modern, functional space; add contemporary features; introduce new vistas and, most importantly, conserve, restore and refurbish the building's fabric.

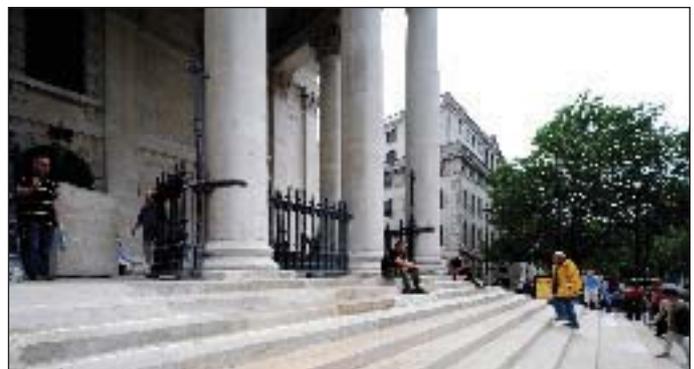
The famous steps leading to St Martin's main entrance inside the west portico. Most of the steps were turned over and refaced rather than replaced with new stone.

At the other end of the church, the famous steps leading up to the west portico presented their own unique challenge. Access to the church had to be maintained which meant the well-worn steps could only be restored in sections. To do so, each individual stone was lifted and its viability assessed – if it was reusable, it was re-bedded; if it was badly worn, it was turned over and the new top surface faced; if it was beyond repair; it was replaced. But 'replacement', of anything, anywhere, was a last resort, a final option that was used sparingly. Inevitably, some new stone (either new or reclaimed) had to be used but, whenever possible, Stonewest recycled and reused any stone that became 'surplus to requirement' during the project.

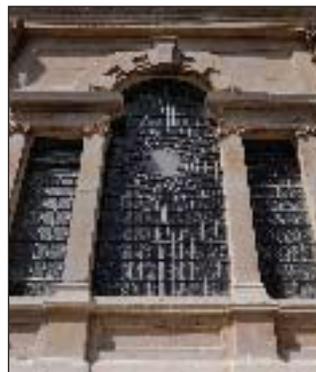
The East Window. Beautifully carved indents were added to replace concrete and correct the depth of the reveals in the three windows.

St Martin's suffered bomb damage during World War Two and much of this had been hastily and cheaply repaired. The East Window was a typical example and the coloured-glass window installed during the 1940s was to be replaced with one more true to the original. Structurally, the depths of the reveals around the main window were too deep and, along with the two secondary windows, had been repaired during the 1940s with concrete. Stonewest removed the concrete, trimmed the openings and restored the reveals with freshly-carved Portland stone plinths, capitals and cornices ready to take the exquisite new window

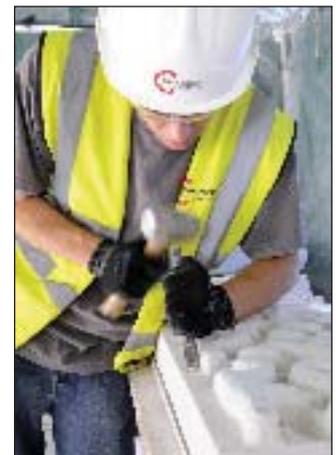
Man at work! A mason cutting a new vermiculated panel.

For most of the masons, every day brought a new challenge: they could be repairing the damage caused by a dog-crank one day; indenting the base of a column the next and replacing a unicorn's nose on another (on the west pediment). Although most of the work was done on site – either in situ, on adjacent scaffold or in the two banker workshops that became hives of activity – the restoration of the vermiculated ashlar wall running along Duncannon Street was a notable exception. Such was the scale and complexity of the task that the wall was removed from site and temporarily reassembled so that the detailing on the new panels could be accurately matched with its neighbours.
